Inventory Data:	
Structure Name	<span style="border: 1px solid black; padding: 2px;">#40 Ross Bridge, Lot 10/11, Conc. I, Elzevir</span>
Main Hwy/Road#	<span style="border: 1px solid black; padding: 2px;"></span> On <input checked="" type="checkbox"/> Under <input type="checkbox"/> Crossing Type <input type="checkbox"/> Navig. Water Rail <input type="checkbox"/> Road <input type="checkbox"/> Non-Navig. Water Ped. <input type="checkbox"/> Other <input type="checkbox"/>
Hwy/Road Name	<span style="border: 1px solid black; padding: 2px;">Bosley Road</span>
Structure Location	<span style="border: 1px solid black; padding: 2px;">1.80 km W of Queensborough Road</span>
Latitude	<span style="border: 1px solid black; padding: 2px;">44.577672°N</span> Longitude <span style="border: 1px solid black; padding: 2px;">77.394569°W</span>
Owner(s)	<span style="border: 1px solid black; padding: 2px;">Municipality of Tweed</span> Heritage Designation: Not Cons. <input checked="" type="checkbox"/> Cons./not App. <input type="checkbox"/> List/not Desig. <input type="checkbox"/> Desig./not List <input type="checkbox"/> Desig. & List <input type="checkbox"/>

Field Inspection Information:	
Date of Inspect

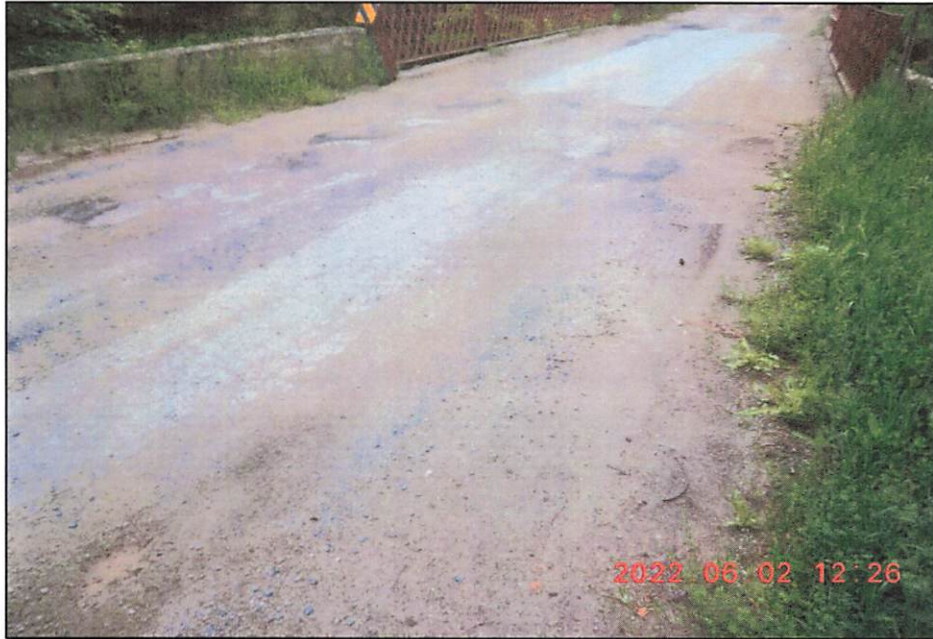
*Photo 1: East Approach and Deck Top Looking West*

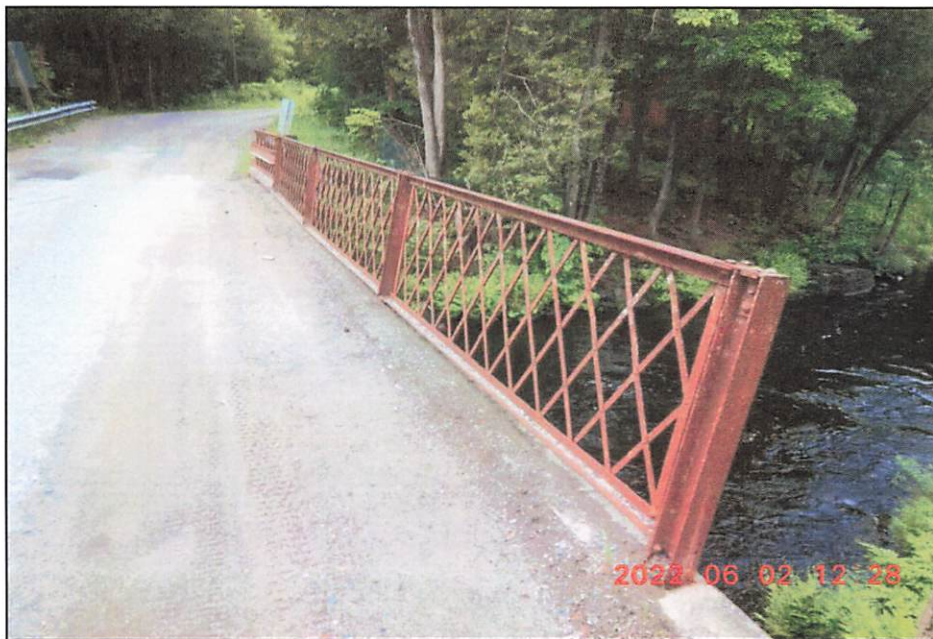
*Photo 2: North Barrier*

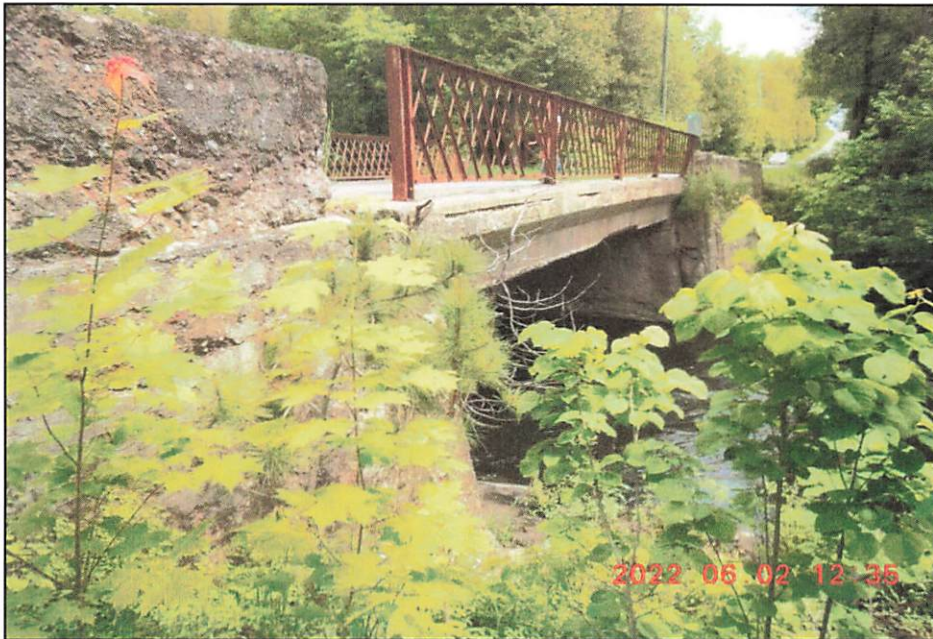
*Photo 3: South Barrier, Fascia, and T-Beam*

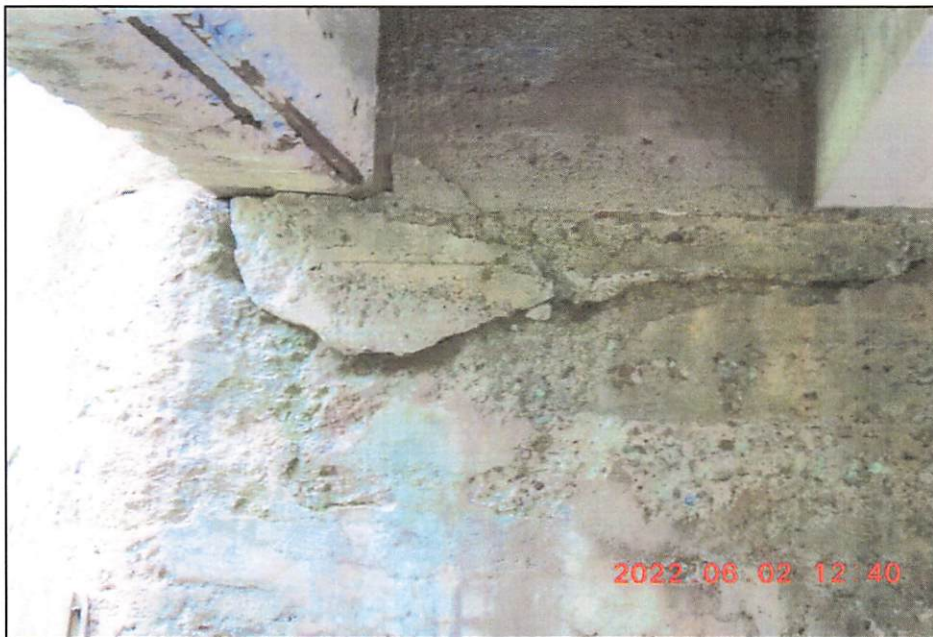
Element Group:	Abutments	Length	N/A				
Element Name:	Abutment Walls	Width	6m				
Location:	Either end of structure	Height	3m				
Material:	Cast-in-place Concrete	Count	2				
Element Type:	Conventional Closed	Total Quantity:	48m <sup>2</sup>				
Environment:	Benign	Limited Inspection	<input type="checkbox"/>				
Protection System:	None					Perform. Deficiencies	Maint. Needs
Condition Data:	Units m <sup>2</sup>	Exc.	Good	Fair	Poor*		
		0	0	5	25	01	
Comments: Typical severe scaling, spalling, and separation at construction joints. Spall under north girder at east end							
Recommended Work: Provide continuous monitoring and replace structure							
		None	<input type="checkbox"/>	6-10 years	<input type="checkbox"/>	1-5 years	<input checked="" type="checkbox"/>
						<1 year	<input type="checkbox"/>
						Urgent	<input type="checkbox"/>

*Photo 4: Cracking and Spalling on East Abutment Wall*

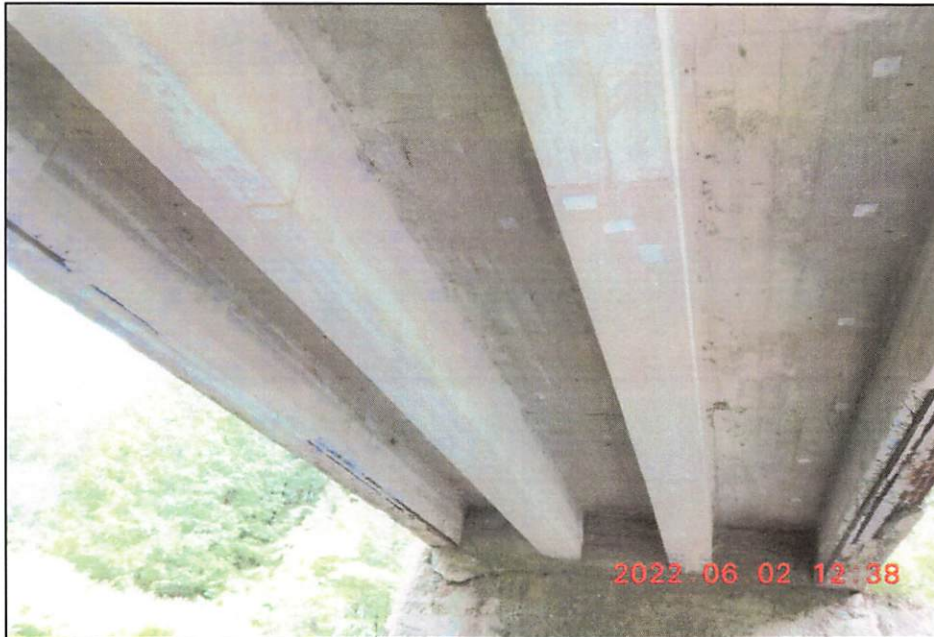
Element Group:	Decks	Length	13m				
Element Name:	Soffit – Thin Slab	Width	5.8m				
Location:	Underside of deck	Height					
Material:	Cast-in-place Concrete	Count	1				
Element Type:		Total Quantity:	75.4m <sup>2</sup>				
Environment:	Benign	Limited Inspection	<input type="checkbox"/>				
Protection System:	None					Perform. Deficiencies	Maint. Needs
Condition Data:	Units m <sup>2</sup>	Exc. 0	Good 0	Fair 71.4	Poor* 4		
Comments: Localized spalling with exposed and corroded rebar at west end. Typical delamination and localized cracking with corrosion staining							
Recommended Work: Provide continuous monitoring and replace structure							
None <input type="checkbox"/> 6-10 years <input checked="" type="checkbox"/> 1-5 years <input checked="" type="checkbox"/> <1 year <input type="checkbox"/> Urgent <input type="checkbox"/>

*Photo 5: Interior Soffit and T-Beams Looking East*

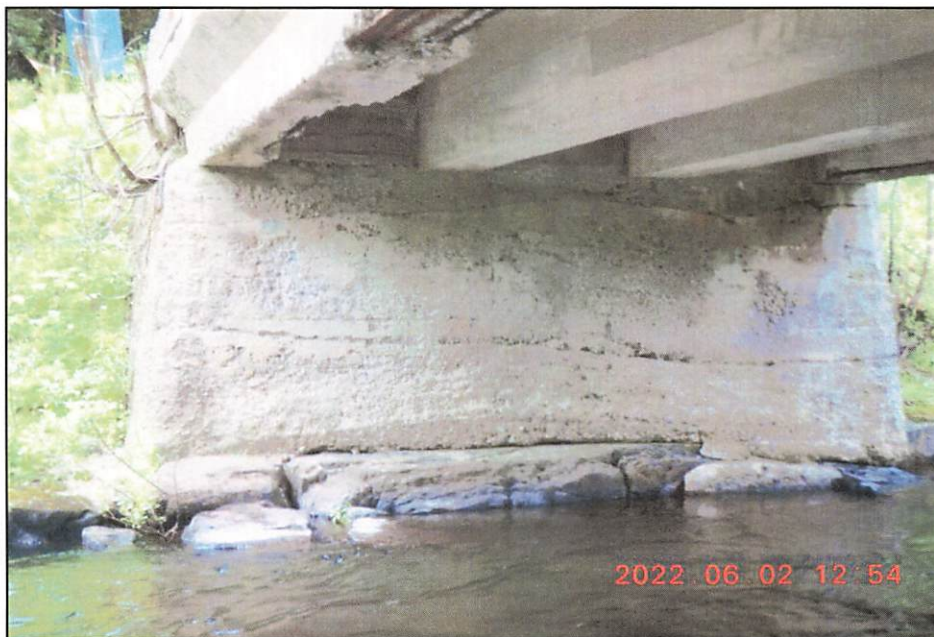
*Photo 6: West Abutment Wall*

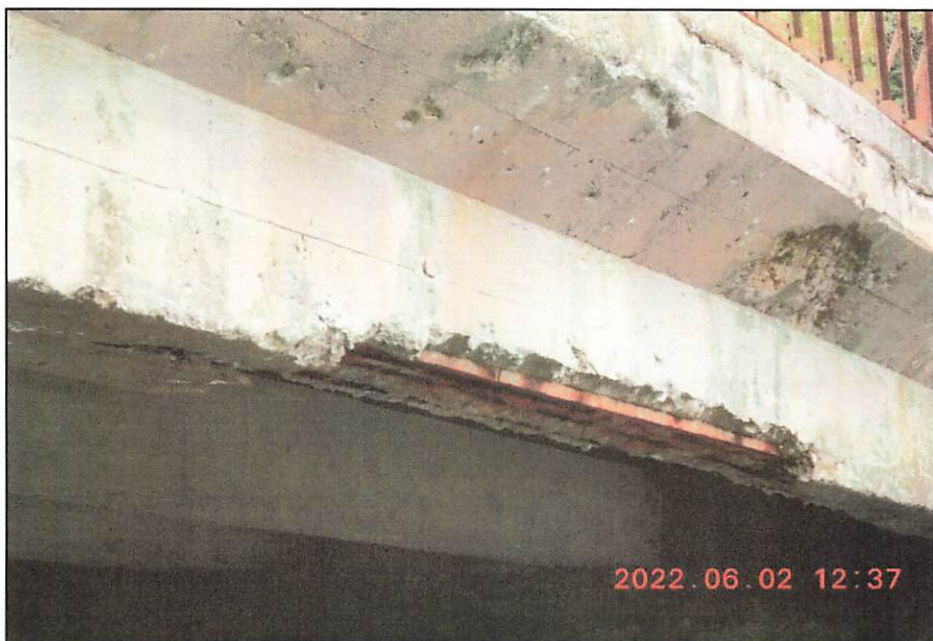
Element Group:	Beams/MLEs	Length	12.5m					
Element Name:	Girders	Width	0.4m					
Location:	Underside of deck	Height	0.7m					
Material:	Cast-in-place Concrete	Count	4					
Element Type:	T-Type	Total Quantity:	90m <sup>2</sup>					
Environment:	Benign	Limited Inspection	<input type="checkbox"/>					
Protection System:	None					Perform. Deficiencies	Maint. Needs	
Condition Data:	Units	Exc.	Good	Fair	Poor*			
	m <sup>2</sup>	0	20	35	35	01		
Comments: Severe scaling in webs. Shear cracks at end of south beam. Typical delamination and spalling with exposed and corroded rebar in interior beams. Localized narrow longitudinal cracking on interior beams at west end.								
Recommended Work: Provide continuous monitoring and replace structure                 None <input type="checkbox"/> 6-10 years <input type="checkbox"/> 1-5 years <input checked="" type="checkbox"/> <1 year <input type="checkbox"/> Urgent <input type="checkbox"/>

*Photo 7: Spalling on South Exterior T-Beam*

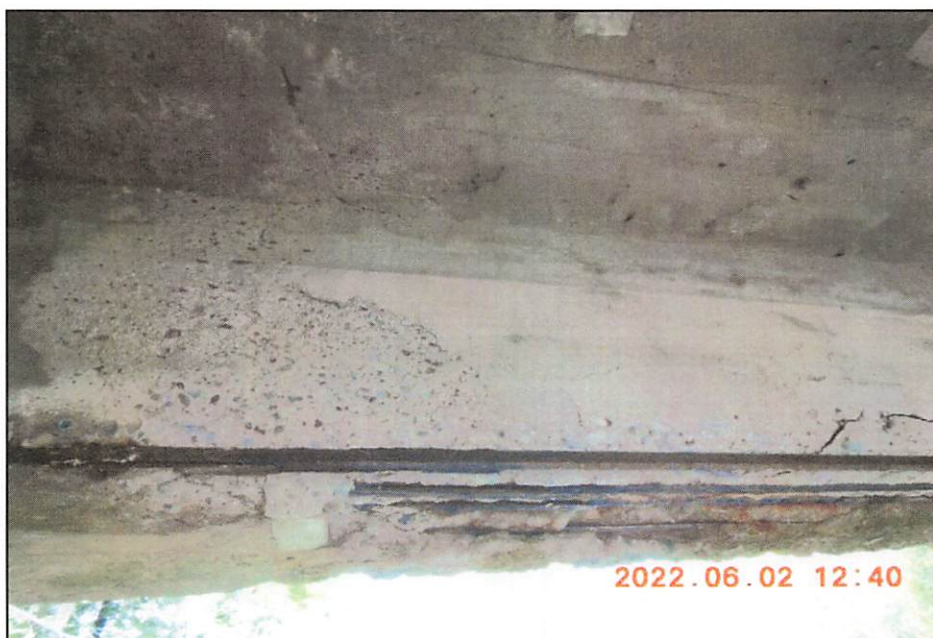
*Photo 8: Spalling on North Exterior T-Beam*

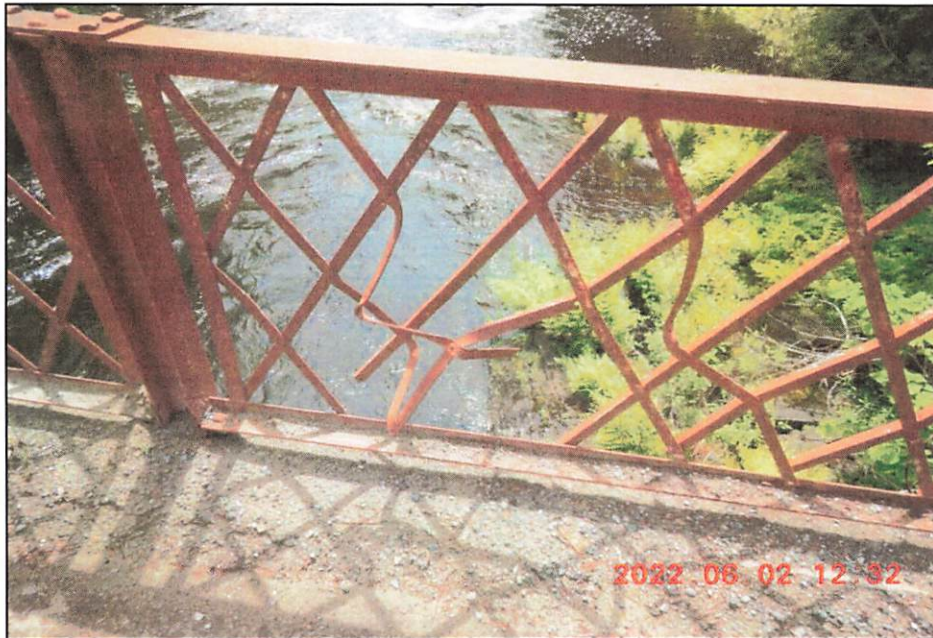
*Photo 9: Deformation on South Barrier*

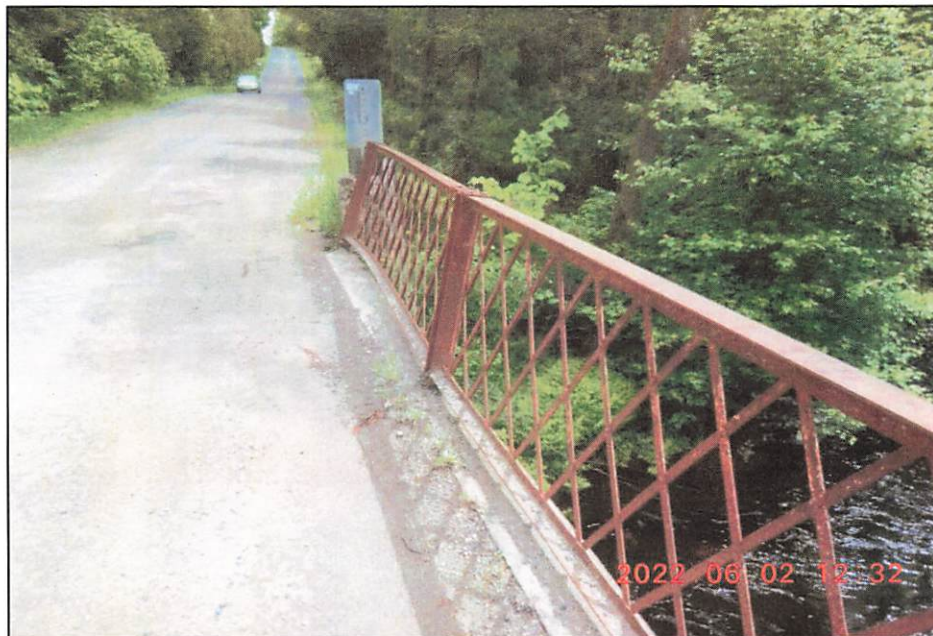
*Photo 10: Outward Rotation of Southeast Barrier*
